Revenue Assurance

Service Diversion

Commercial Theft of Service Part - 3

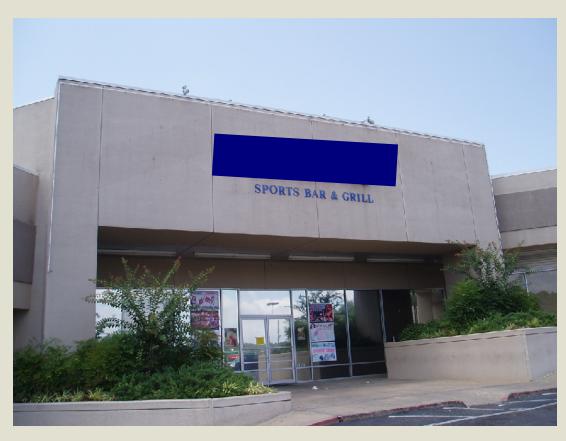
Not just Residential - Internal Tampering \$24,000 billed and collected in 2008

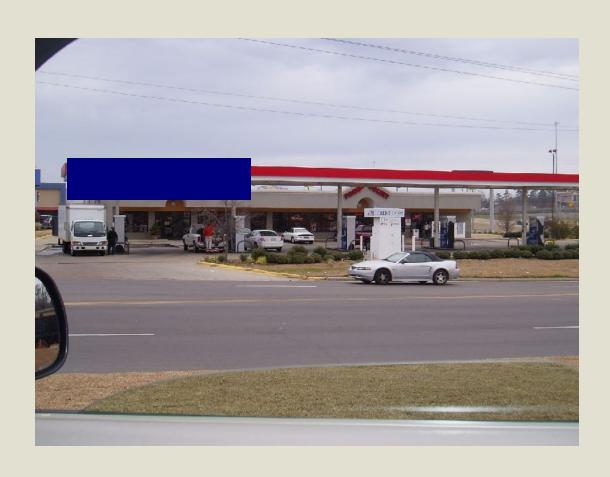
Approximately \$65,000 Billed - Settlement reached after litigation on these two locations owned by same Business Partner

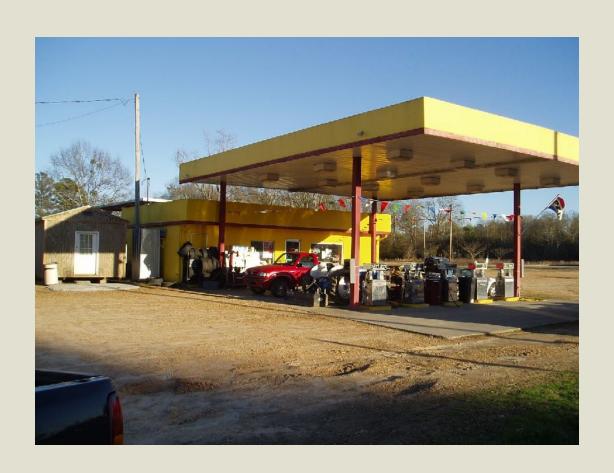
Convenience store - stolen meter \$2,000 billed and collected

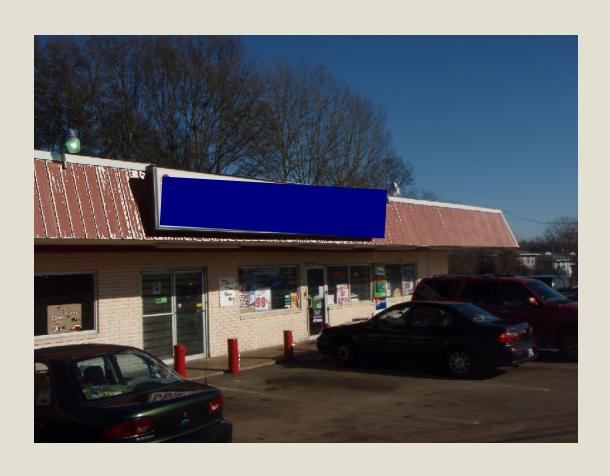
Two (2) meters here - billed over \$6,000 Both tampered internally

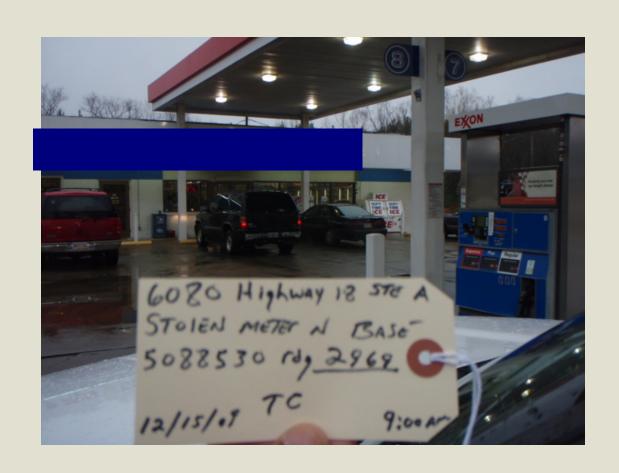
\$15,696 paid

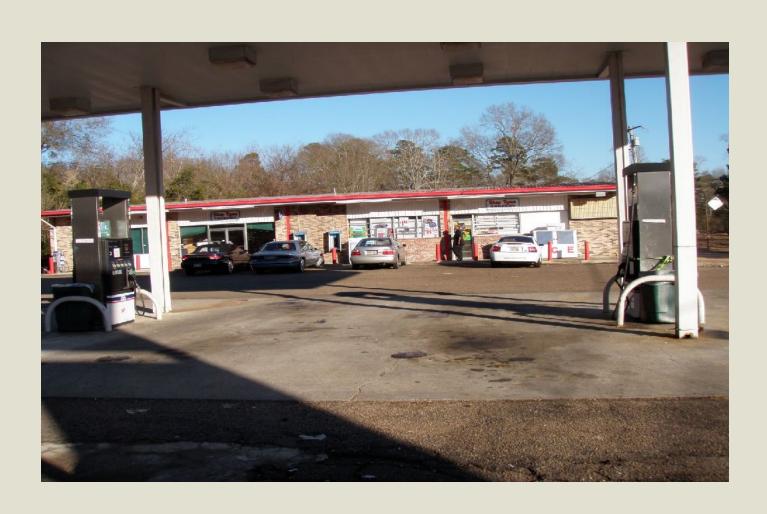
CT wire cut - \$12,827 Settlement reached

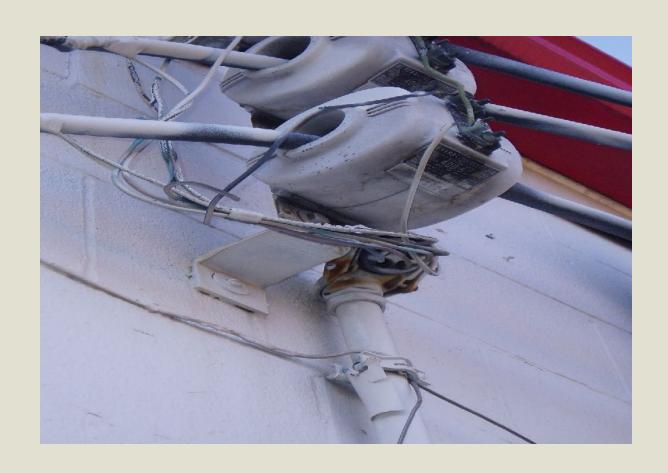
Cut the CT Wire

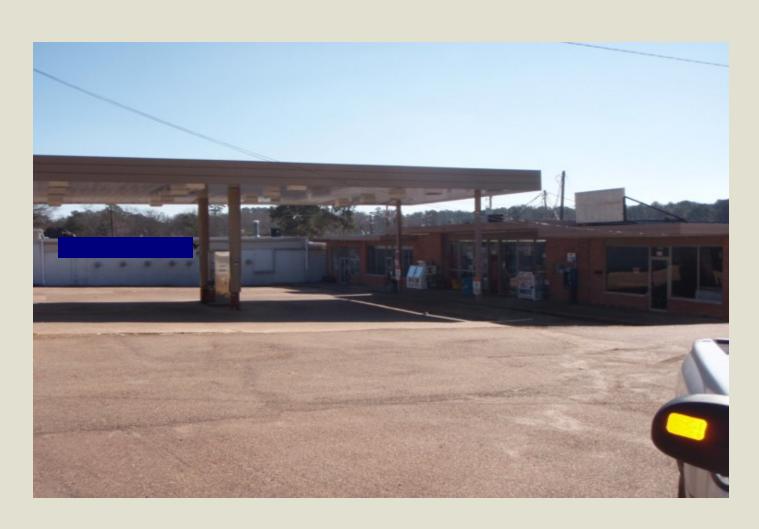
\$15,813.94 - other business and residence also tampered with

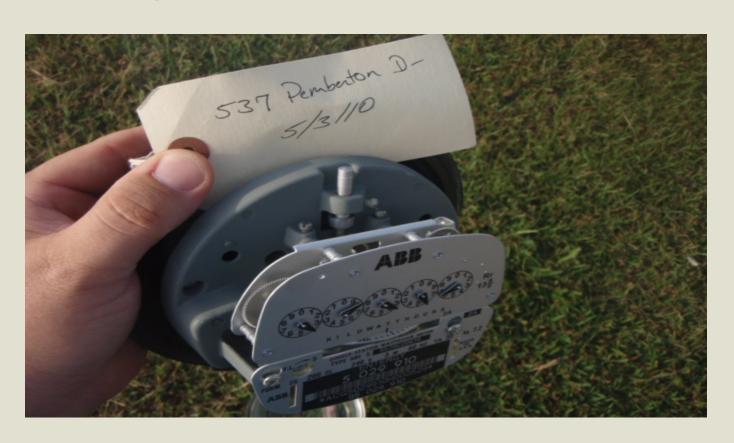
Residence of BP on previous 2 locations \$16,808.00 awaiting approval

Pivots tampered

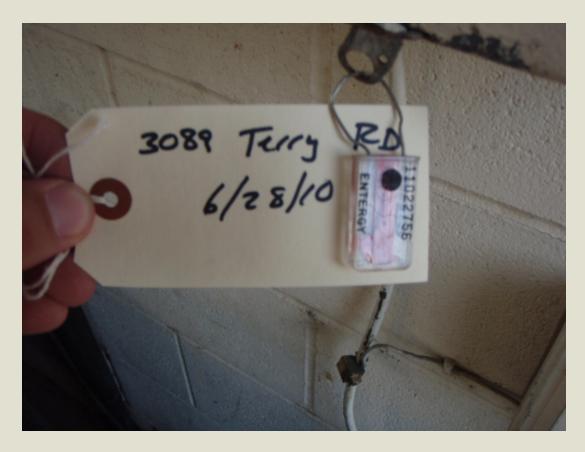
Auto Detail Shop. The kW was Reading Zero. Seal Tricked and You could Not tell until You tugged on it.

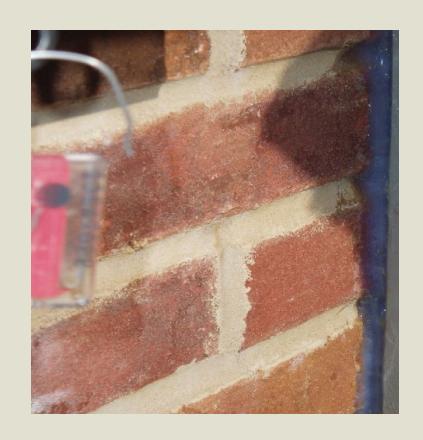
You had to look closely to see this tampered seal. When it was pulled on it came open. This Investigation resulted over \$4,000 being billed. The meter had been internally tampered. The "B" phase current wire was cut.

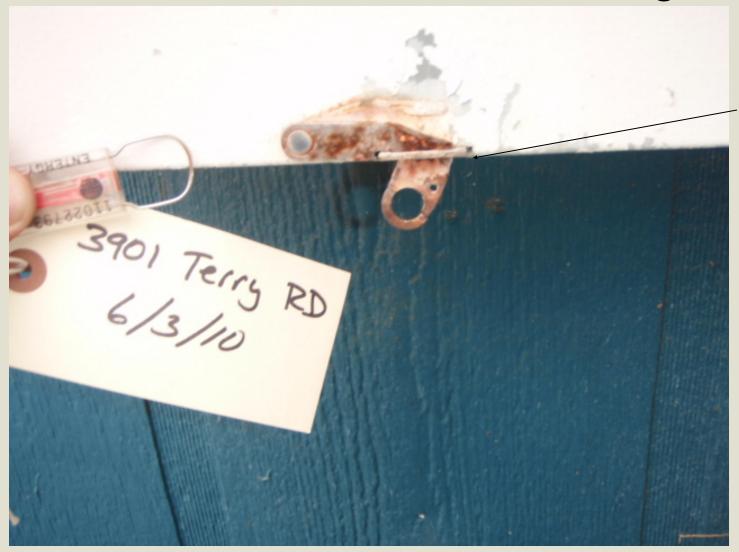
Seal tab was cut

\$15,737

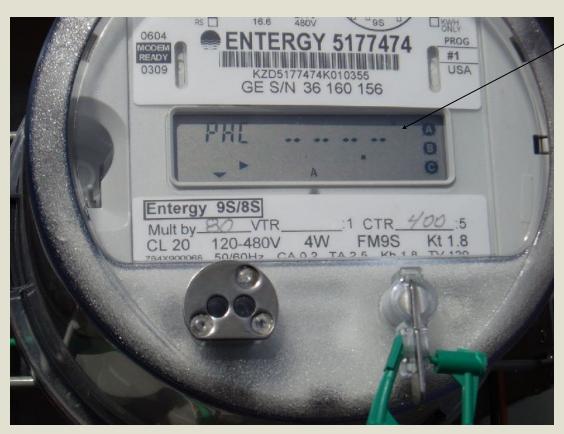
Notice no "c"
Phase amps?
This is a WYE
Installation

In this case, tong all phases and calculate load. Time meter

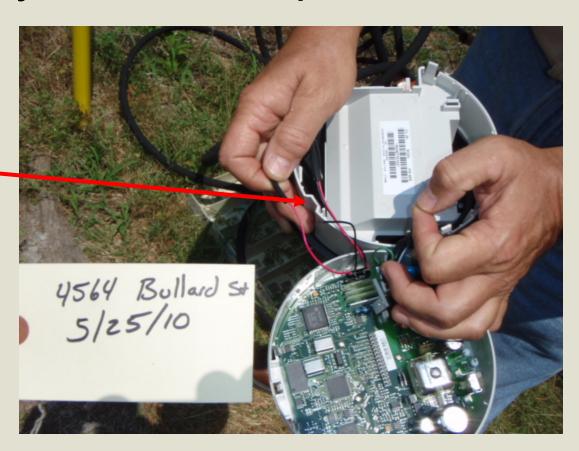
Notice black wire cut? This is a current wire.
