Performing Investigations for Analytical Revenue Protection Cases

Joseph Princiotta
Revenue Protection
Con Edison
New York, NY

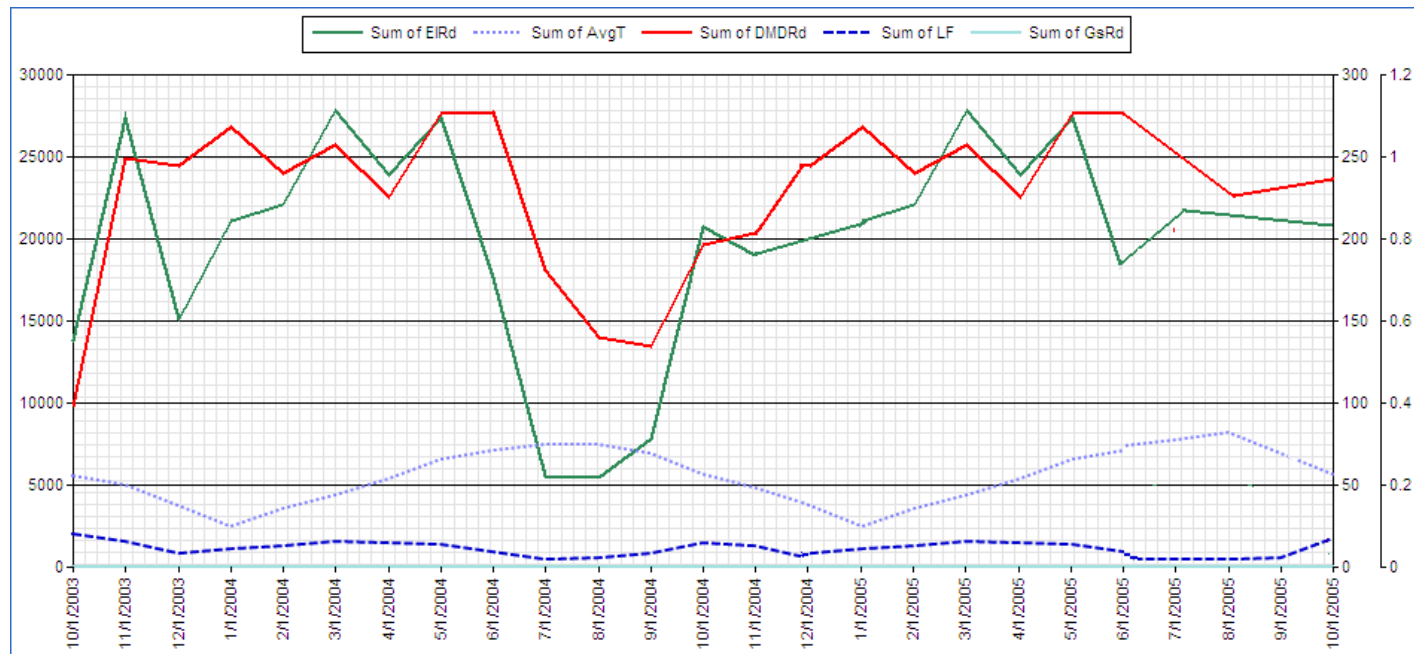
Load factor is extremely low for type of business and pattern is very erratic. Please determine if this location is still being actively used. This customer has three accounts in the immediate vicinity. Other 2 look normal. Suspect intermittent tampering, most likely with CT equipment.

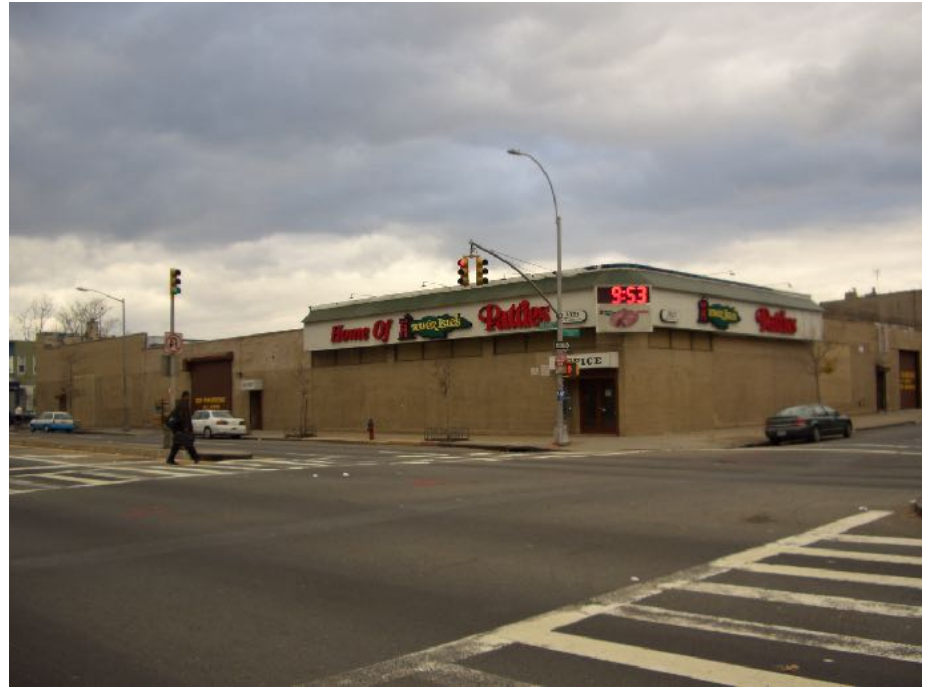
- What was found at site
 - Very large facility, too large for the consumption
 - Needed to confirm meter carried all the load

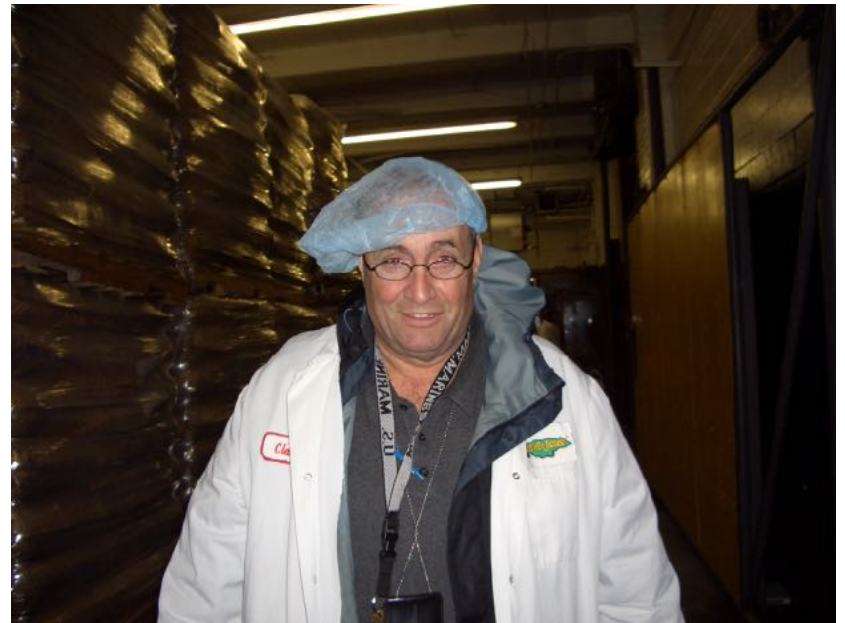
- What was found at site
 - Brought in Inspector Clouseau (a k a Eddy)
 - Performed energy audit of all equipment

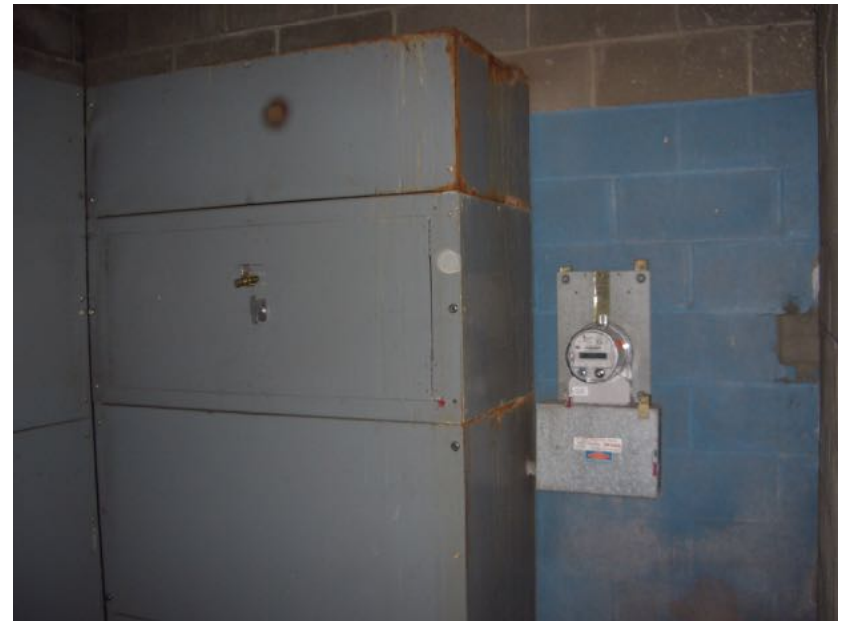
- What was found at site
 - Large CT equipment
 - Locks and seals intact
 - Needed to look further because of data

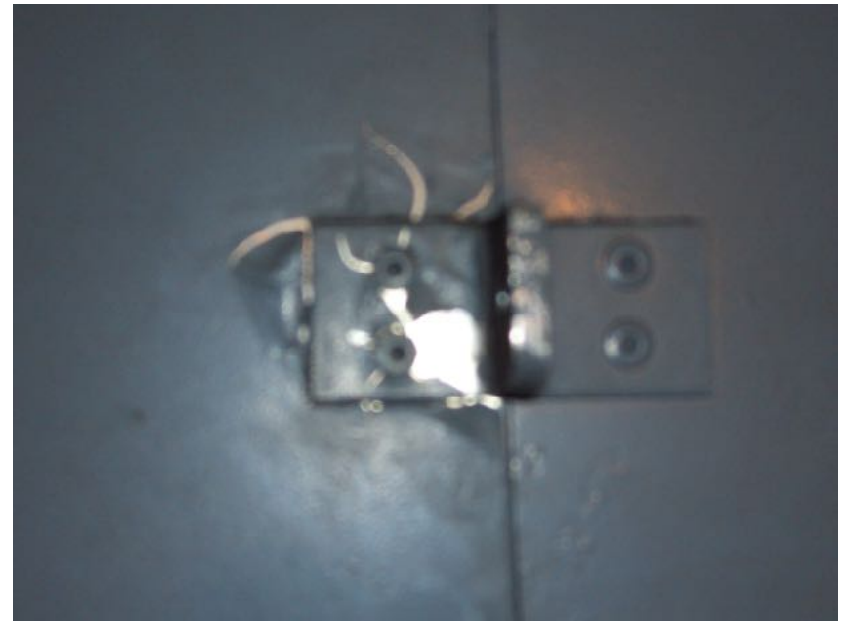
- What was found at site
 - Lock on CT cabinet showed signs of tampering
 - Seal was removed

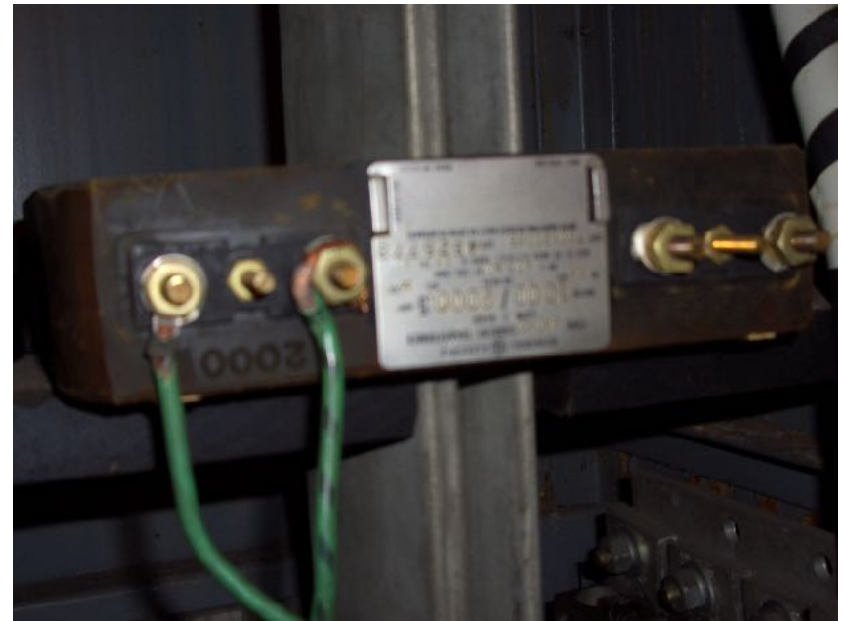
- What was found at site
 - Coil wires and nuts showed signs of wear
 - Obviously secondary wires were removed often

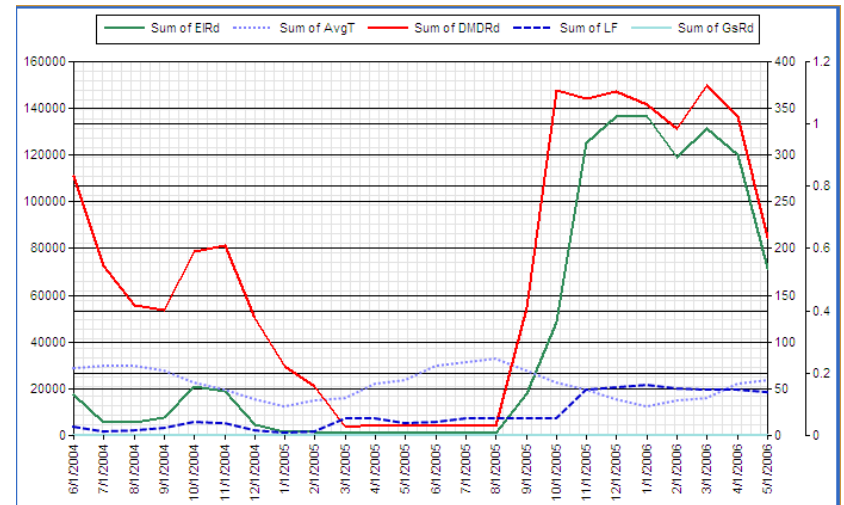
- Customer back billed for \$400K + \$200K LPC
- Equipment locked and sealed
- Consumption went from 20K/mo to 140K/mo

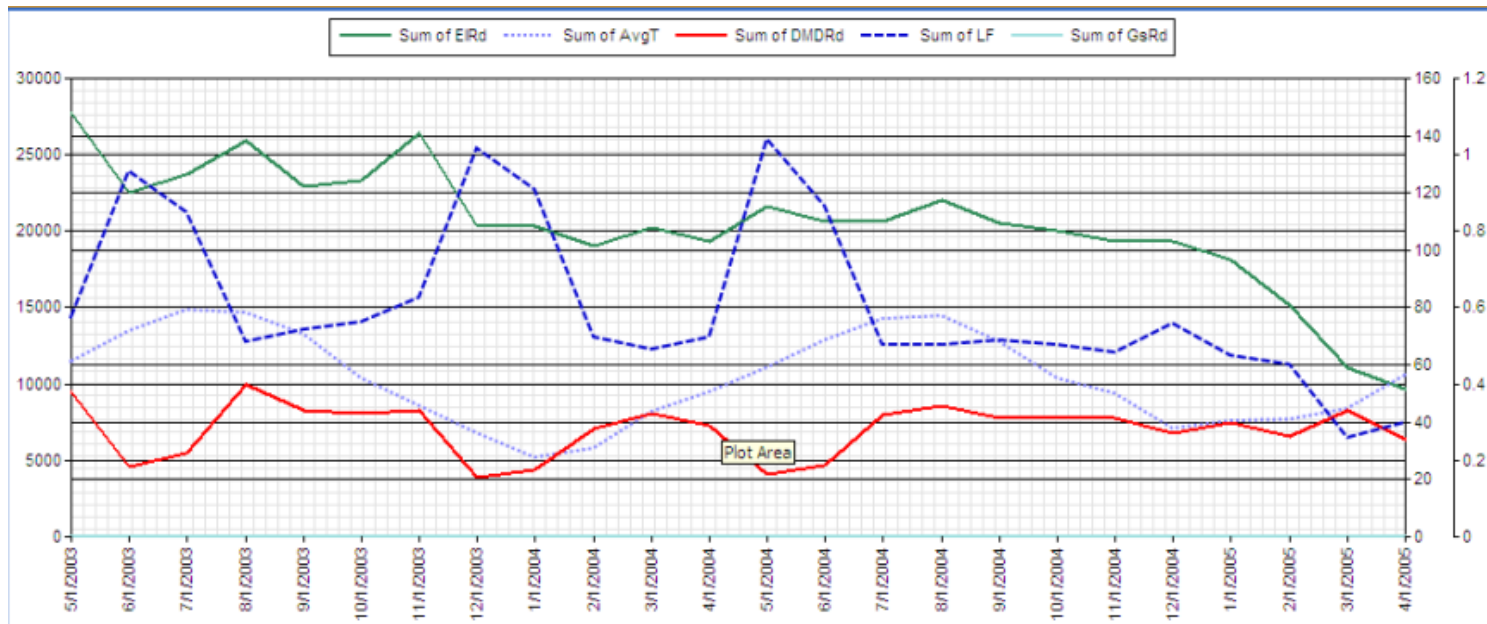
Investigate per elect slope drop. Current consumption down to 10K. Historically, consumptions was 20K. Corresponding drop in LF indicates that condition is intermittent but just began.

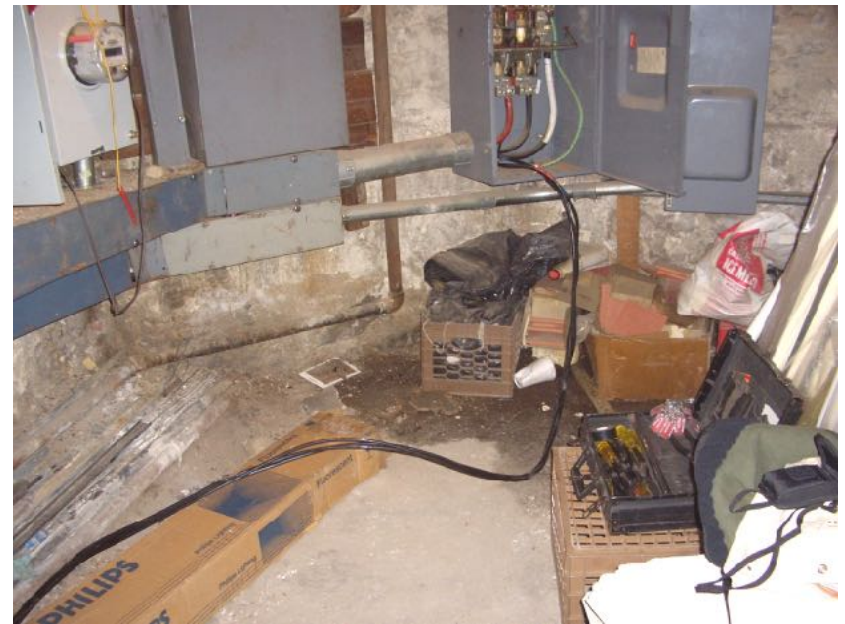
- Room locked, waited 1 hour to get in
- Meter set, locked, sealed & recording
- Service switch box & breaker panel open
- Flashed service, all went out
- Cables in picture were not there

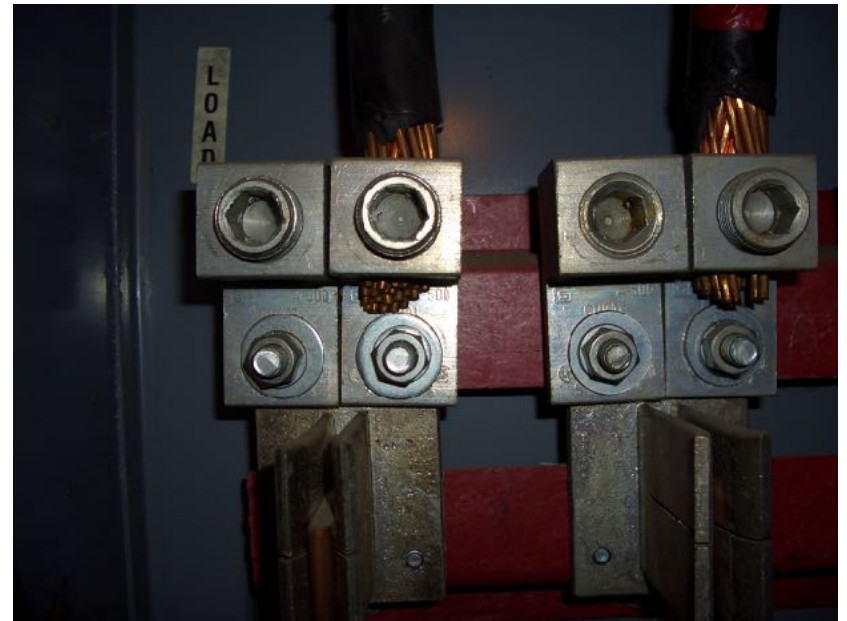
- What was found at site
 - Consumption drop could not be explained
 - Set new meter and returned in 1 week, locked again but waited
 - Reading OK

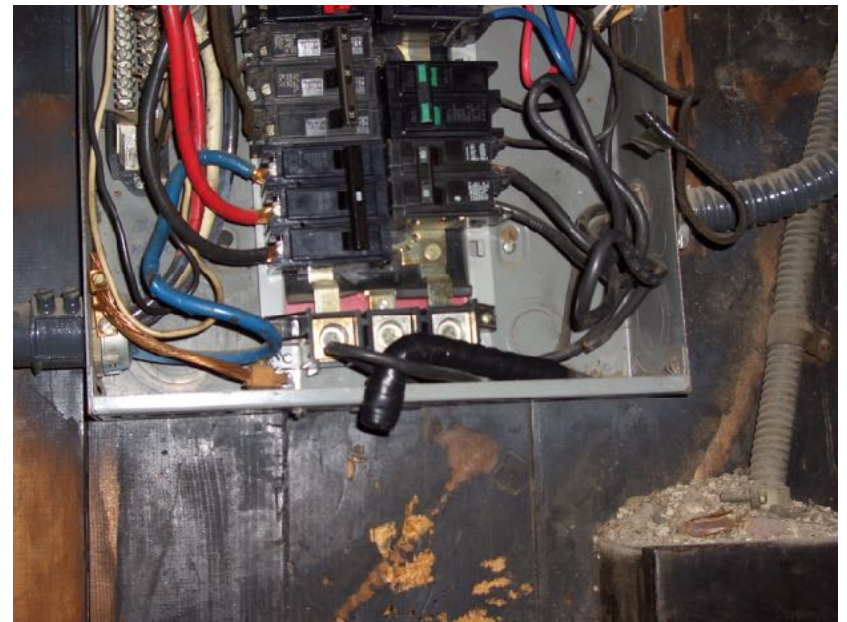
- What was found at site
 - Looked around and found cables with color coding on ends
 - Found marks on service switch terminals
 - Found marks on breaker panel

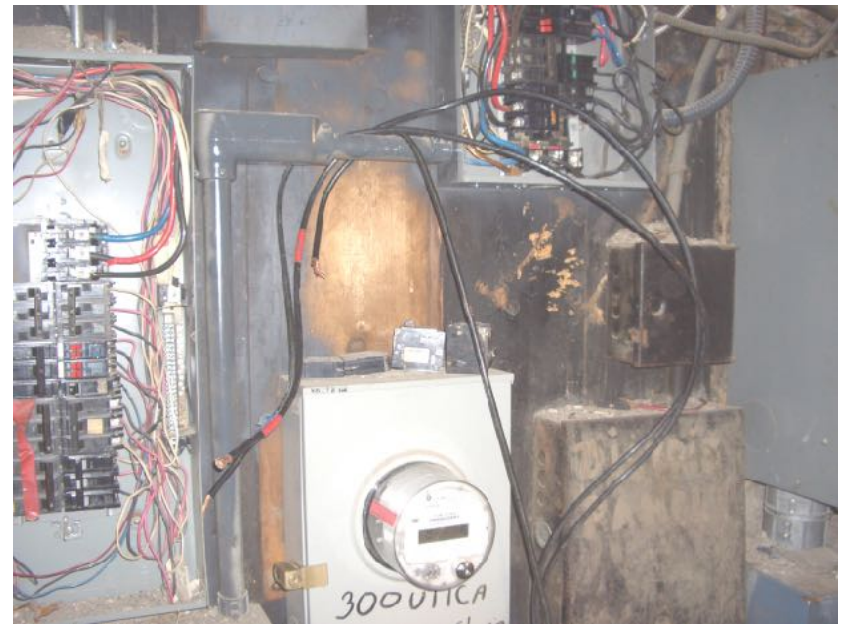
- What was found at site
 - Customer was periodically connecting cables from service switch to breaker panel
 - Took confidence in analysis and good investigative skills to keep looking

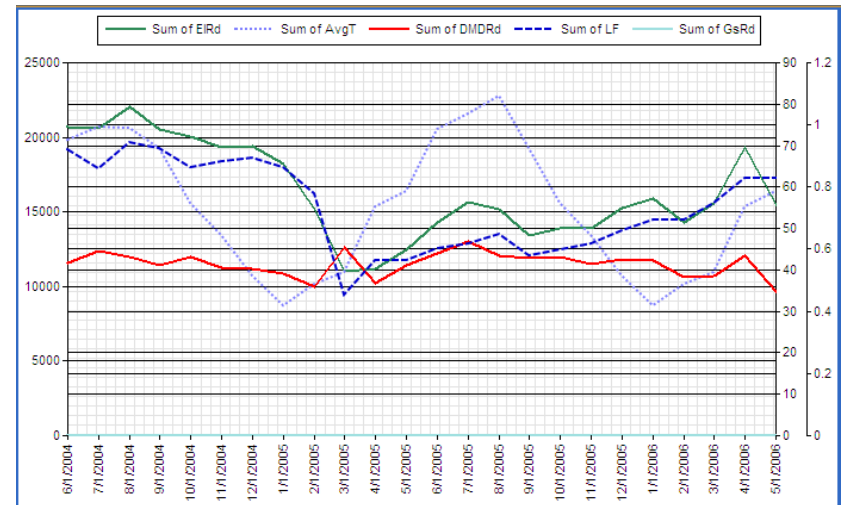
- Customer back billed for \$3K + small LPC
- Value of case was large since it was caught early
- Customer tried to show no theft by conserving but is now creeping up

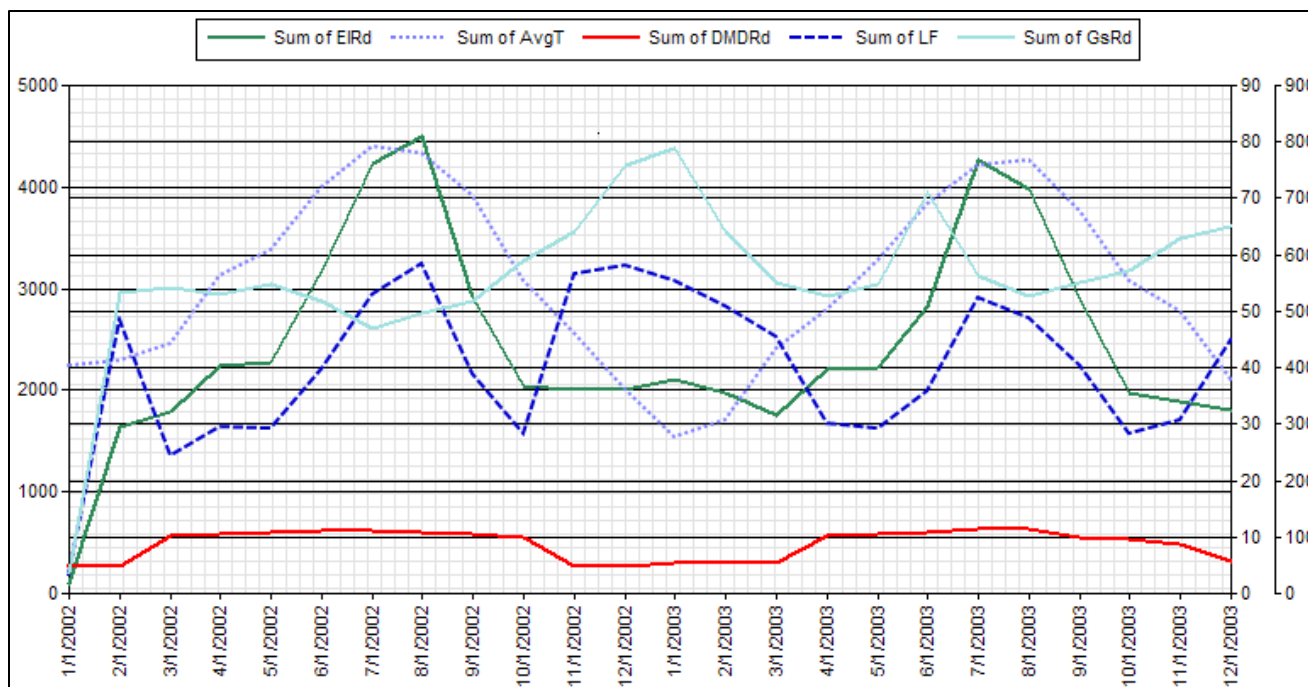
Open 7 days. Pasta, seafood, pizza, variety of food. Very consistent seasonal pattern but the base electric consumption is too low compared to the base gas consumption for this type of business. Suspect one phase not registering or part of load being bypassed.

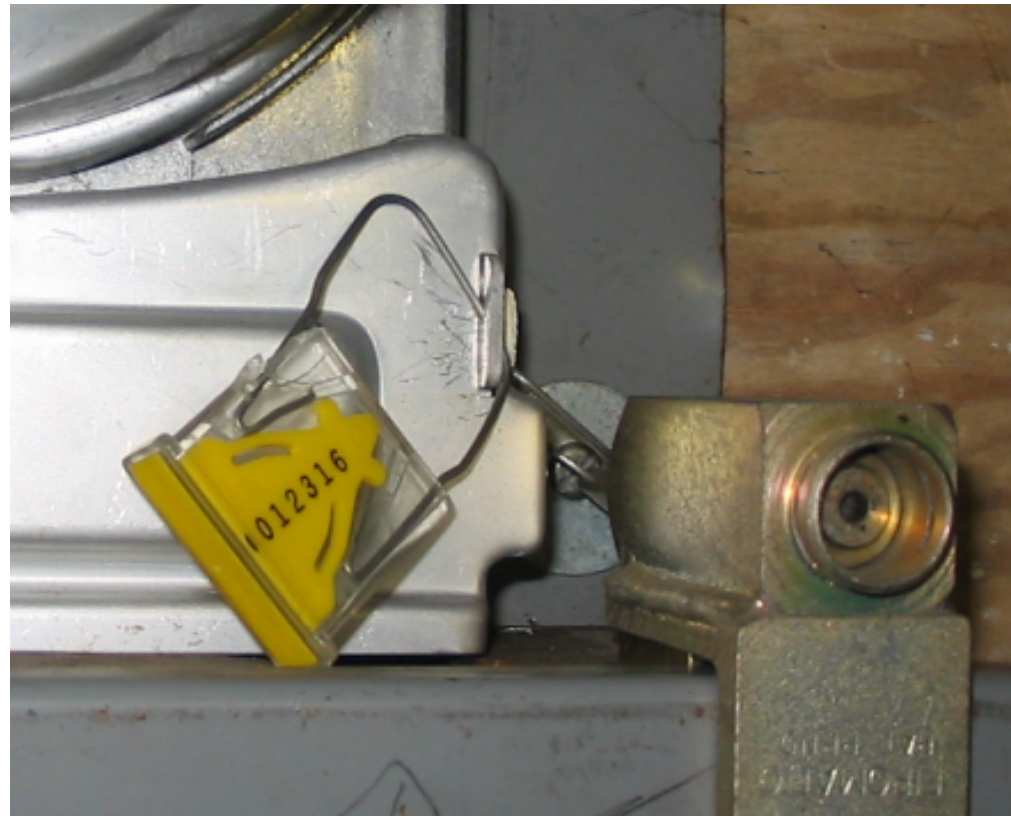
- What was found at site
 - Base seal was wrong color
 - No seal on terminal cabinet

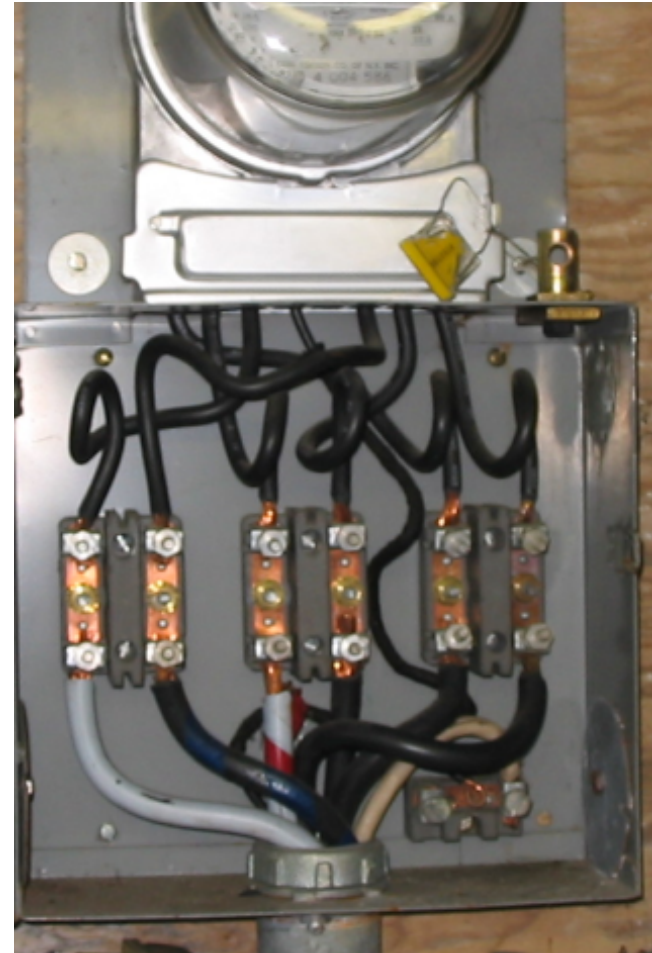
- What was found at site
 - Terminal blocks appeared normal
 - Load at call (meter comparison to amps)

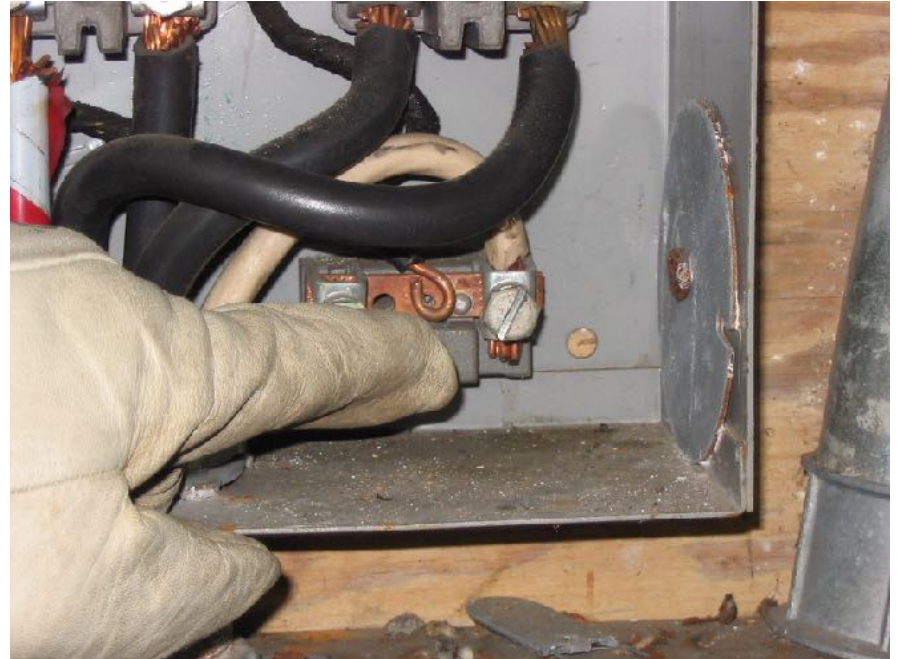
- What was found at site
 - Further investigation identified neutral wire screw missing
 - Caused 40% reduction in all readings

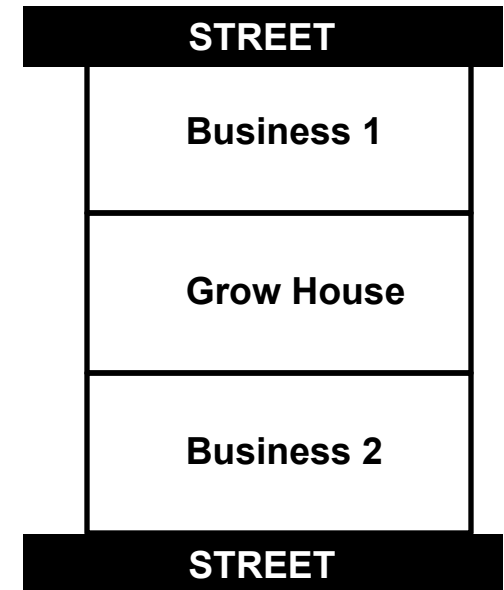
- Approach at site:
 - DEA met offsite and brought to grow house (hidden between active businesses)
 - Performed energy audit to determine load
 - 80 1000W lights, pumps, AC, heaters, etc
 - Large consumer
 - Found fire damaged inactive meter, thorough investigation did not locate taps
